I did some "third party" testing for Patrick and here's what I found:

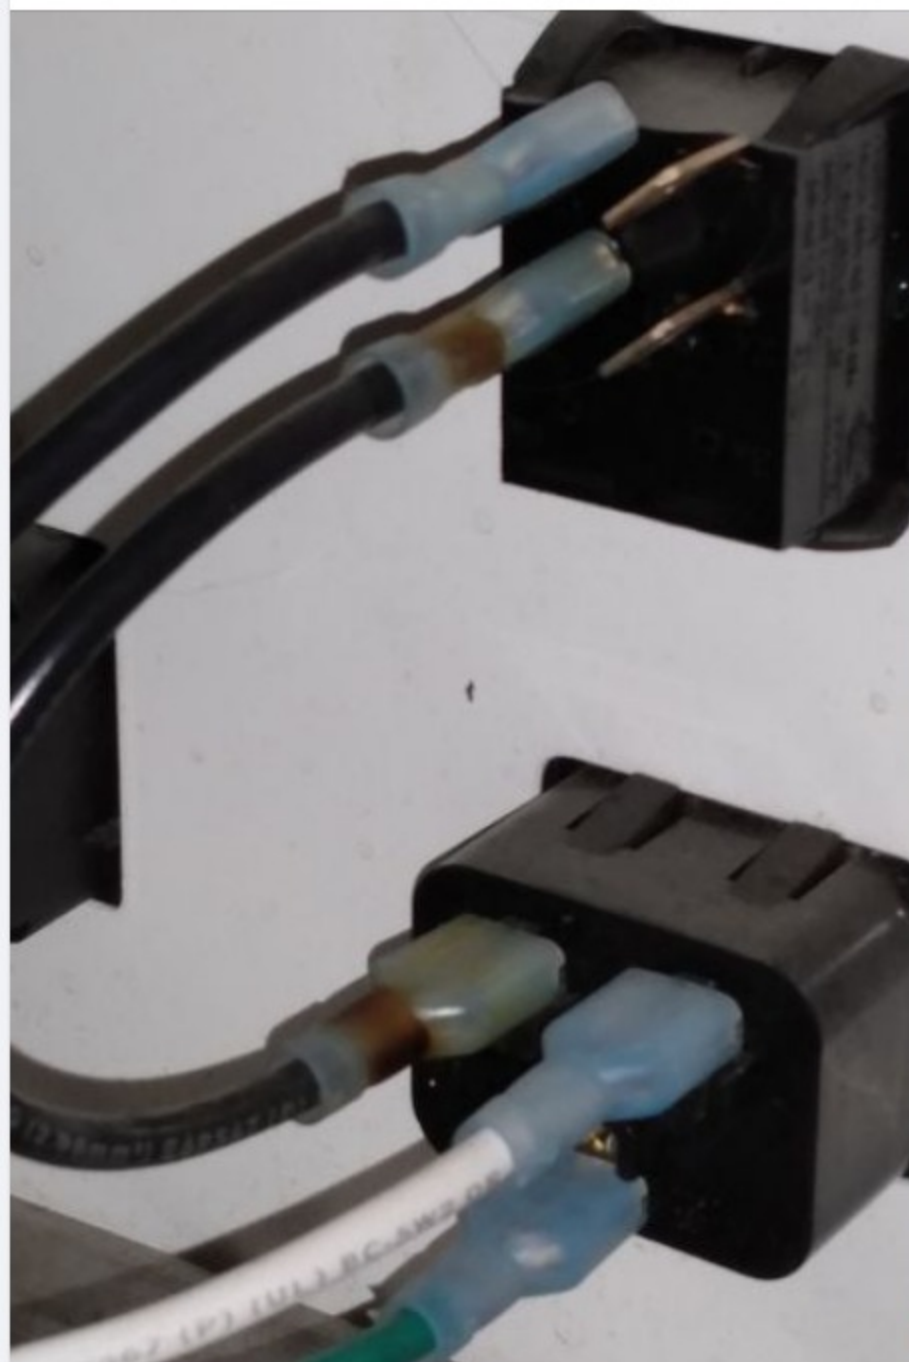
2) The first photo shows the potential problem that the Cable Cooler could help with. If you look at the light blue connectors (spade lugs) you'll see some brown discoloration. That's ungood and is caused by heat over a period of time. This can be caused by two primary factors: too much current going through that connector, and/or a loose crimp that holds the wire in the spade lug. The crimps I've inspected in the HR have all looked very good, so that's probably not the issue here. Too much current over time is the other likely cause.

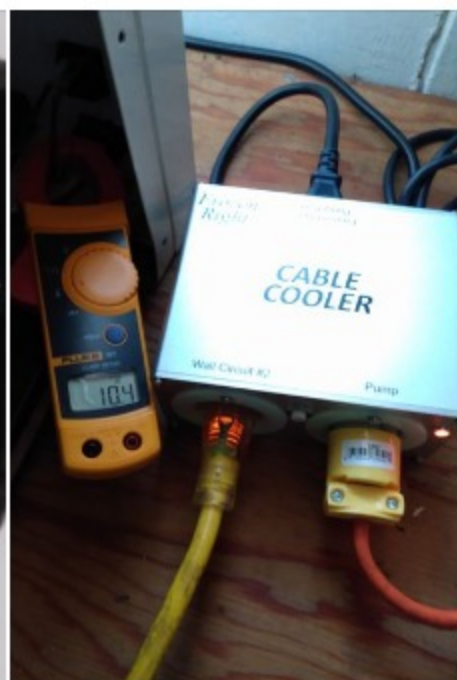
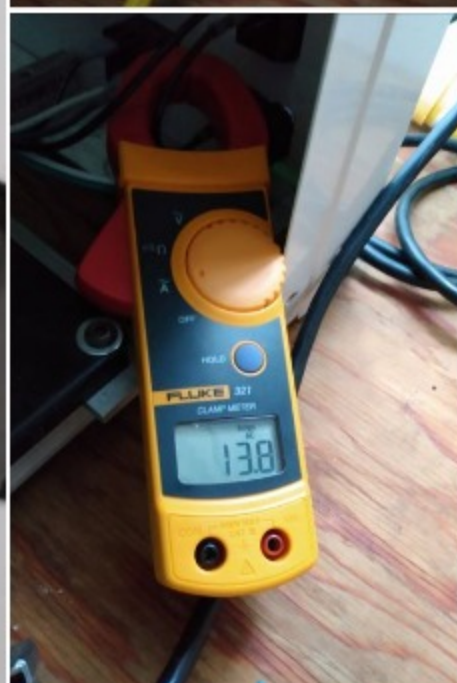
4) Below are also two new photos showing the current draw at the power input inside the freeze dryer. One showing before the Cable Cooler was installed and the other showing it with the Cable Cooler connected. With the HR in freeze dry mode (freezing/heating/vacuum all on together) the meter at the machine's input showed 13.8 amps. Remember I saw 14.1 amps at my fuse box the other day. This is due to a difference in line voltage from the power company and is normal. It's usually about 121 volts and when I took the reading of 13.8 amps the voltage was 124.1 volts. That voltage difference explains the current difference between the two days. I felt it important to show both input readings and explain why they were different, because I also wanted to show the input reading at the point where the overheating can be seen and I previously showed this reading in a different location. Otherwise it might look like I'm comparing apples with oranges. The Cable Cooler splits the input power to the HR and takes the pump current from a separate circuit in your home. The result is a lower current being drawn through the HR, lowering the chance of overheating the internal wiring.
